PERFORMANCE DETERIORATION
DUE TO ACCEPTANCE TESTING AND FLIGHT LOADS
JT9D JET ENGINE DIAGNOSTICS PROGRAM

W. J. Olsson

UNITED TECHNOLOGIES CORPORATION
Pratt & Whitney Aircraft Group
Commercial Products Division

1. Report No. NASA CR-165572		2. Government Accession No.		3. Recipient's Catalog No.	
4. Title and Subtitle Performance Deterioration due to Acceptance Testing and Flight Loads; JT9D Jet Engine Diagnostic Program				5. Report Date January 22, 1982

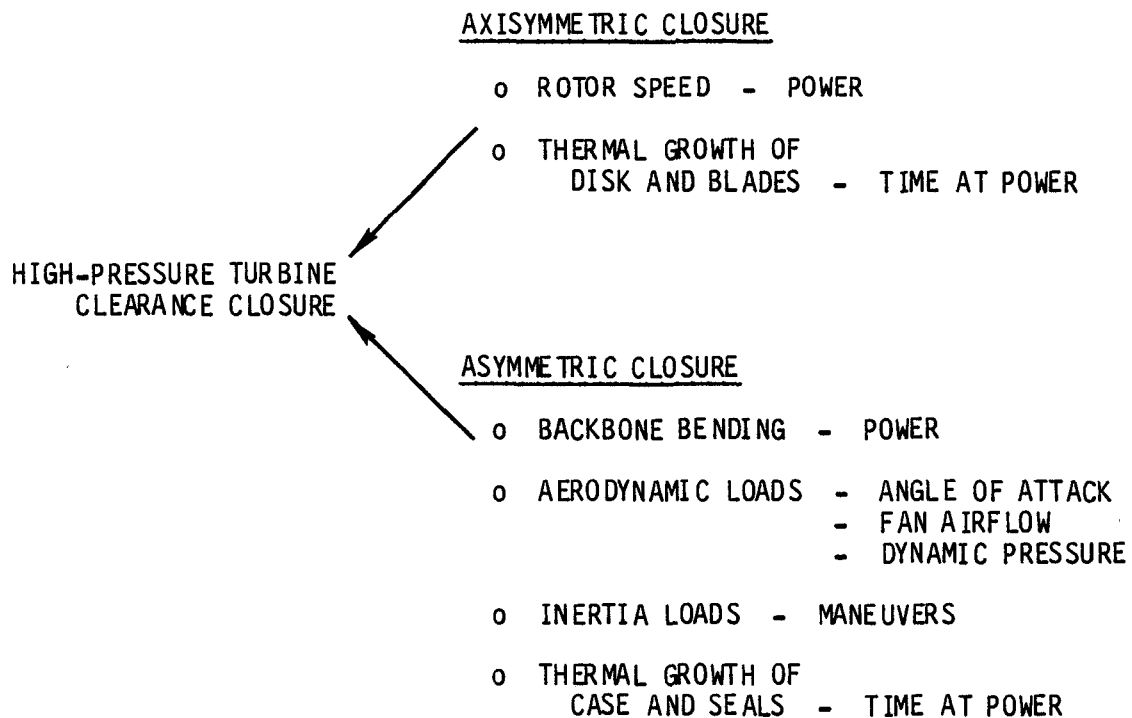
Figure A-3 High-Pressure Turbine Clearance Closure - Closure in the turbine results from engine power, time at power, angle of attack, fan airflow, dynamic pressure, and maneuvers.

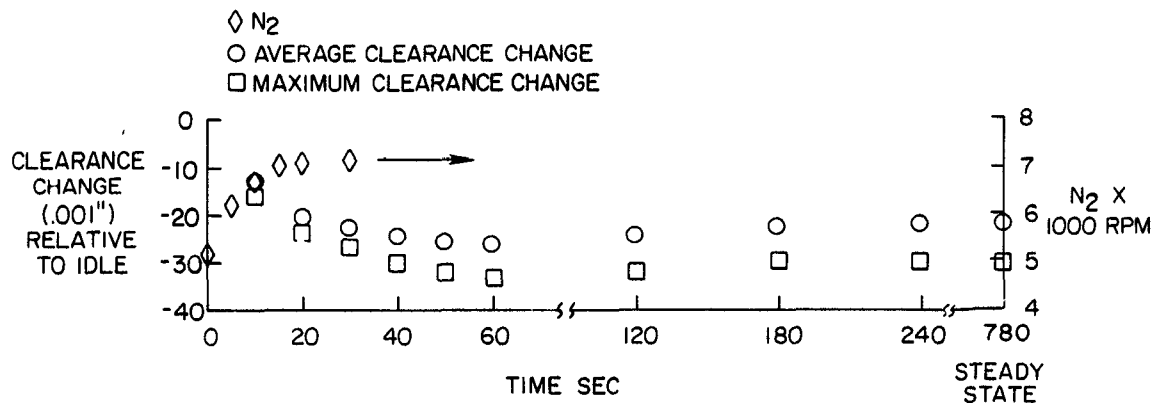
Figure A-4 First-Stage Turbine Blade-to-Seal Clearance Changes During Snap Acceleration from Stabilized Idle.

Note that the high-pressure rotor is nearly up to speed within 15 seconds. The tightest closure condition, both axisymmetric and maximum (axisymmetric plus asymmetric), occurs in slightly more than 1 minute with closure values of -0.026 and -0.033 inch, respectively. While power is maintained at constant value, the turbine blade-to-seal clearance slowly opens until, at 4 minutes after the acceleration, it appears to stabilize at -0.022 inch axisymmetric and -0.030 inch maximum closure relative to stabilized idle.

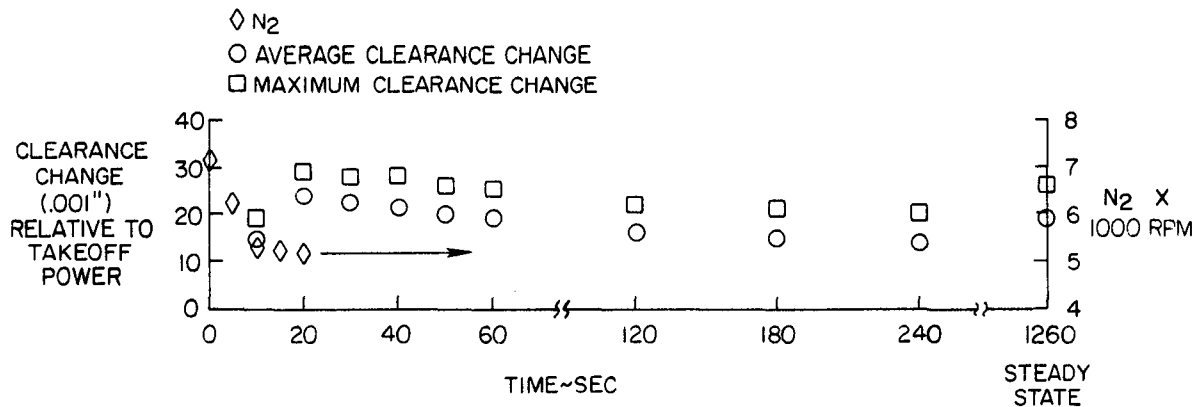
The engine speed drops to the idle level in 10 to 12 seconds. This transient resulted in the average clearance opening 0.024 inch in 20 seconds and the minimum clearance (at the 215-degree location) opening 0.029 inch. As rotor assembly and static structure subsequently cool, the clearance first closes, then opens, and appears to stabilize about 0.003 inch tighter than the idle clearance prior to the acceleration. This clearance indicates that the disk temperature still is above its initial idle temperature.

Figure A-5 First-Stage Turbine Blade-to-Seal Clearance Changes During a Snap Deceleration from Maximum Power to Ground Idle.

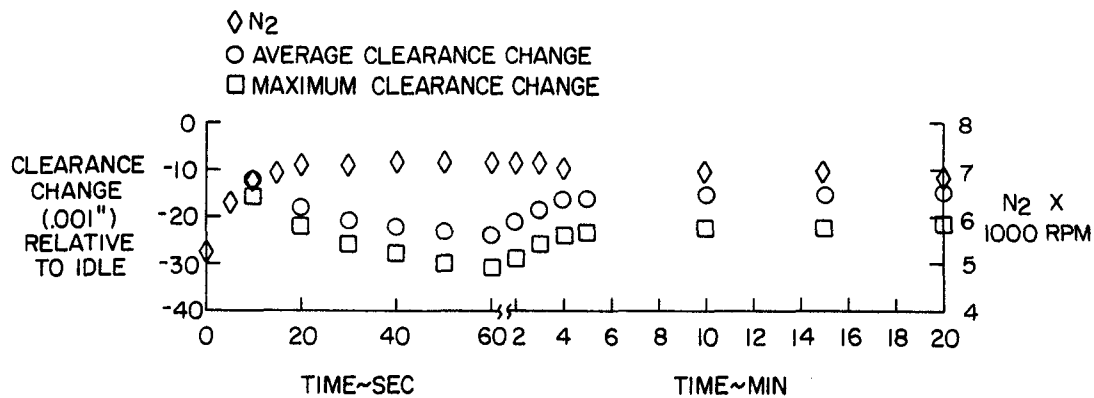
Figure A-7 presents a plot of axisymmetric and maximum clearance closure relative to stabilized idle clearances. Note that, as would be expected, the response due to the initial acceleration duplicates that of the prior snap acceleration. After the first minute, the clearances start to open due to thermal growth effects. This clearance opening effect is greater than that following the snap acceleration (Figure A-4) due to the lowering gas temperatures during simulated climb as compared to constant gas temperature during the constant power ground run.

Note that in both acceleration cases, the asymmetric clearance closure (that is, maximum minus average) increases with time following the step change in power with the peak occurring 60 to 70 seconds after the snap acceleration. This same effect was seen in the Flight Loads Test results (see Figure 5-14, Section 5.3.2 of this document).

Figure A-7 First-Stage Turbine Clearance Change During Simulated Full Power Take-Off and Climb.

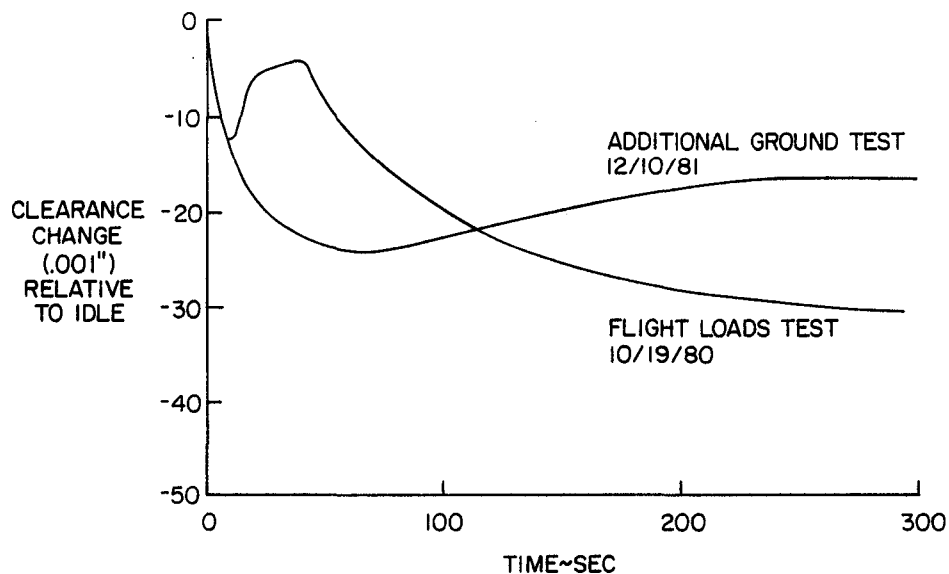
The maximum axisymmetric closure was less in the JT9D-7R4 engine. This advantage is reduced slightly when the combined asymmetric closure effects due to thrust backbone bending and aerodynamic loads are added, since they are both greater at 70 seconds than at 300 seconds after completion of the acceleration.

Figure A-11 Comparison of First-Stage Turbine Axisymmetric Clearance Change During Take-Off and Climb.

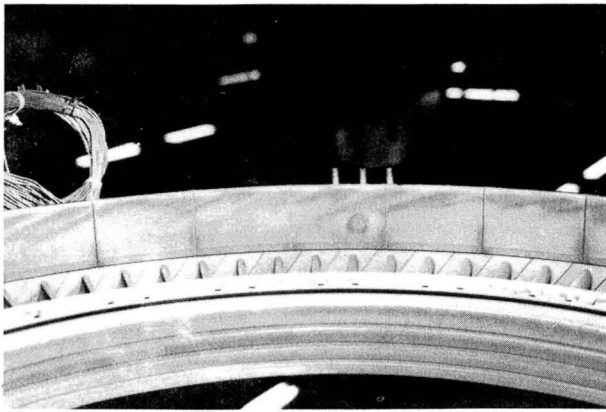
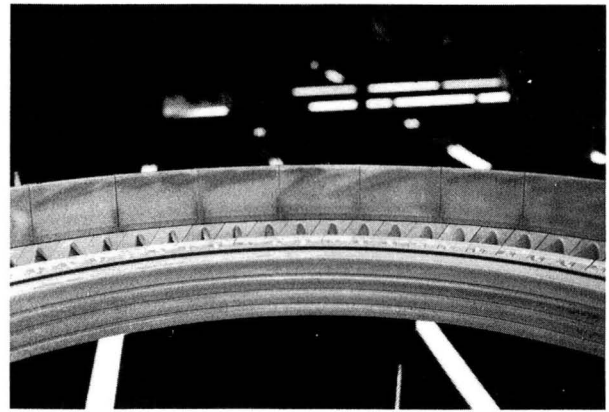
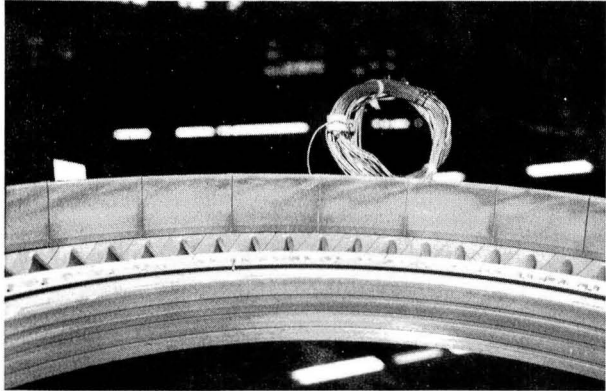
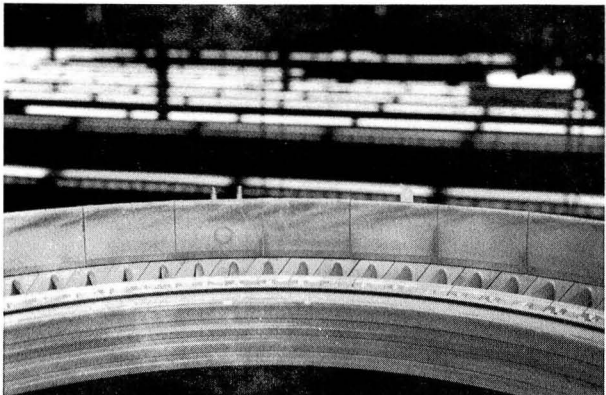
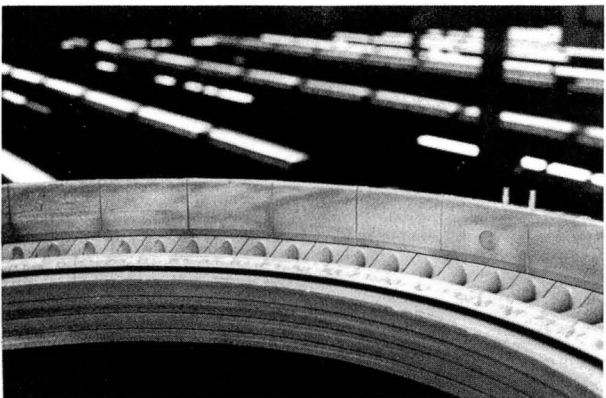
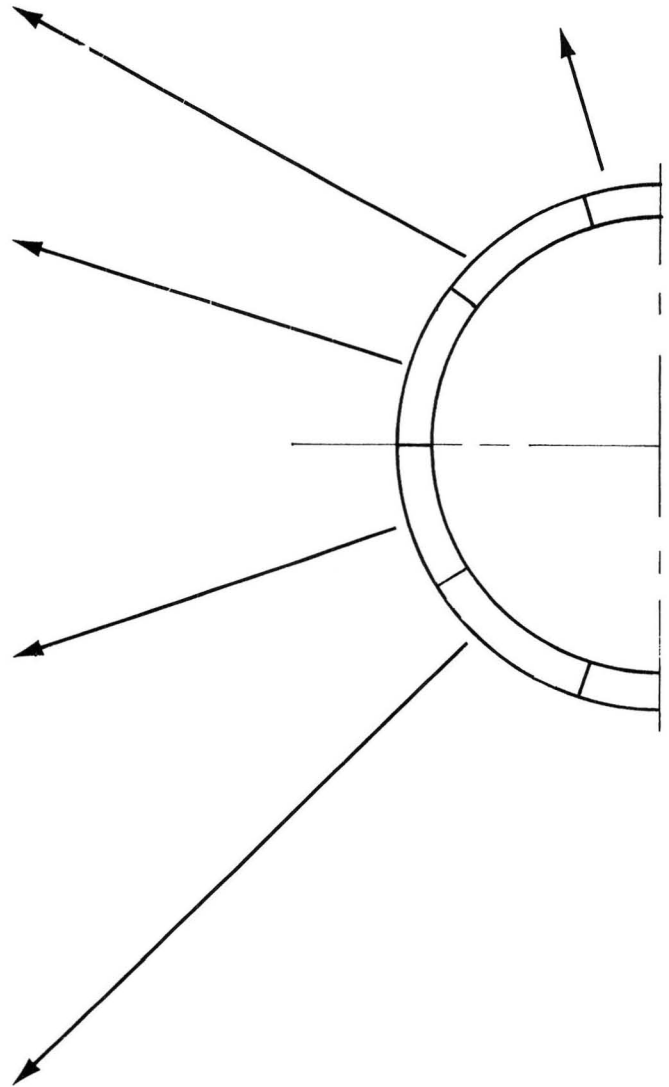
First-Stage High-Pressure Turbine Outer Air Seal Assembly After Test Program; (81C-153-23 and 81C-153-14 through -17)

Upper and Left-Hand Portions.

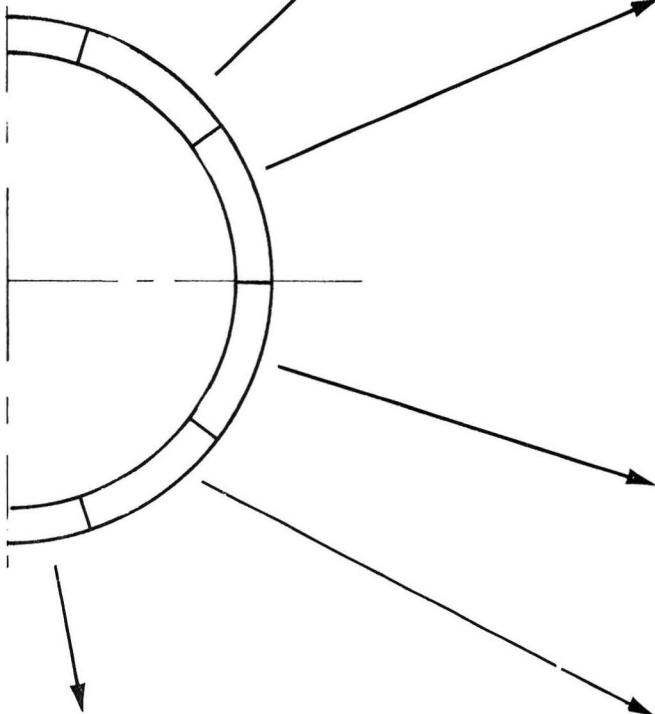
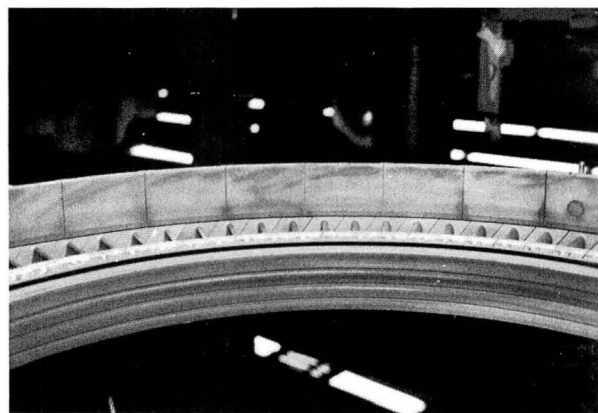
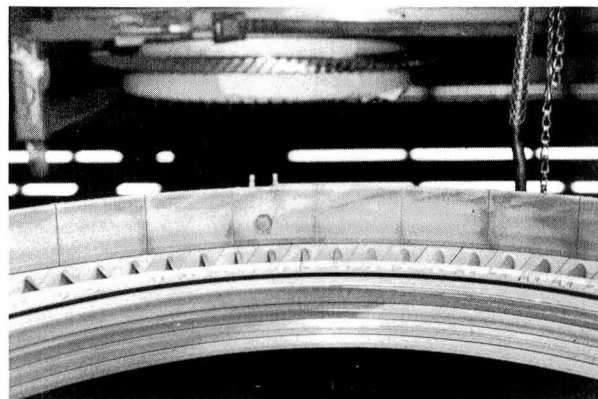
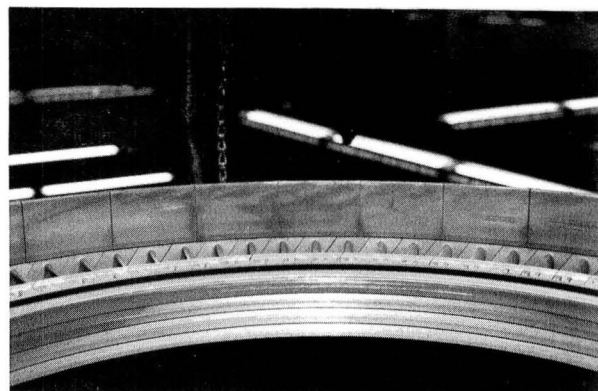
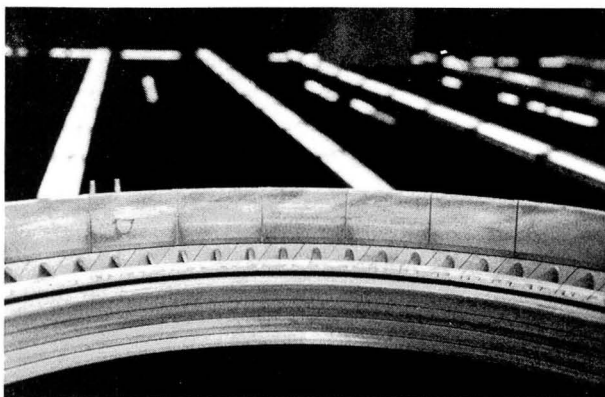
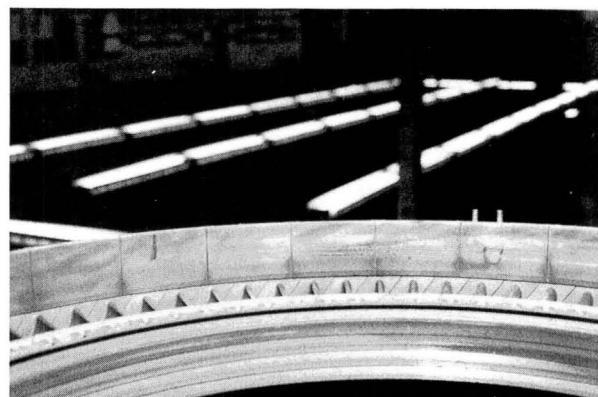
First-Stage High-Pressure Turbine Outer Air Seal Assembly After Test Program;
Lower and Right-Hand Portions. (81C-153-18 through -22)
